PDS100 Application Note: The use of Transient Earth Voltage probe as sensor for Switchgear diagnostics

CASE STUDY 2 (Doble Client Conference 2011, ACCA committee meeting)

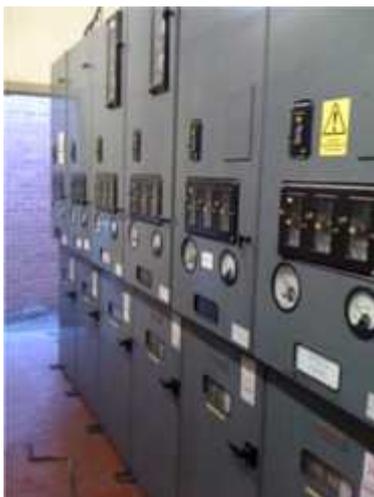
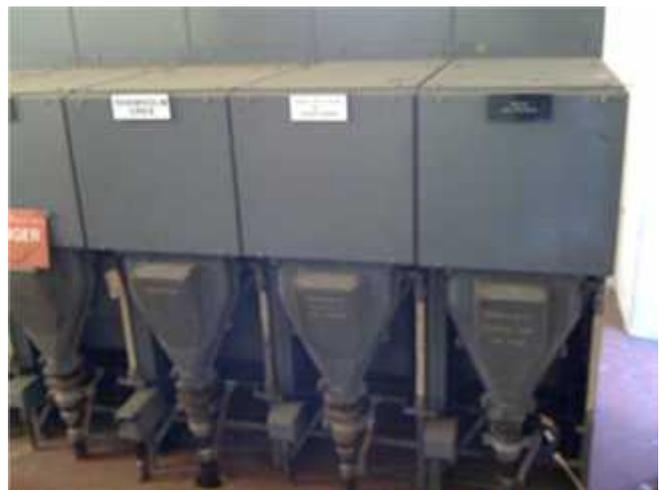
FIGURE 1 shows a Reyrolle LMT, 440A, oil-filled circuit breaker making up a typical 11kV distribution switchboard configuration commonly found in the UK.

(a) Front of Switchboard

(b) Rear of Switchboard

Front and Rear Views of Reyrolle 11kV 400A Oil-Insulated Circuit Breaker

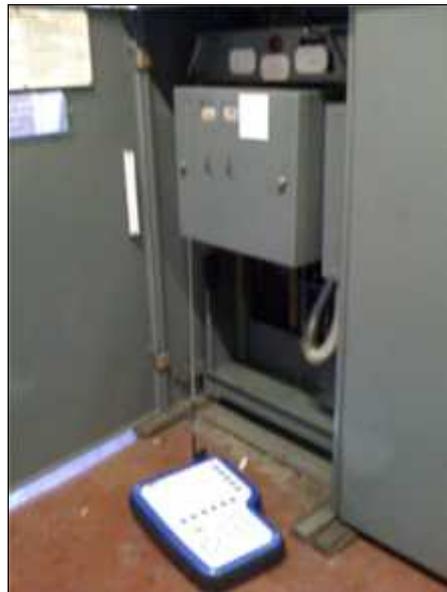
Further RFI measurements were captured at the front of the switchboard. Each measurement location required the circuit breaker cubicle door to be opened to provide increased accessibility to the RFI emissions, FIGURE 3. Comparison of the front and rear RFI measurements for the circuit breaker identified that the uplift in the lower frequencies was strongest to the front of the unit, FIGURE 4.

Recording RFI Emissions from the Front of the Circuit Breaker
FIGURE 3

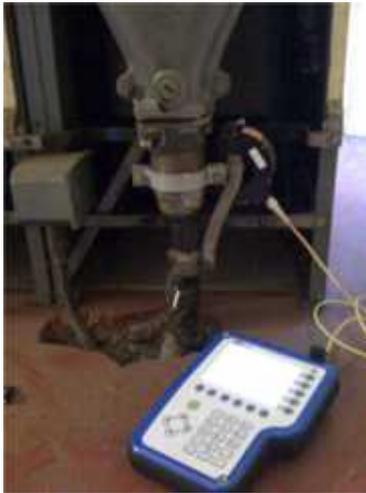
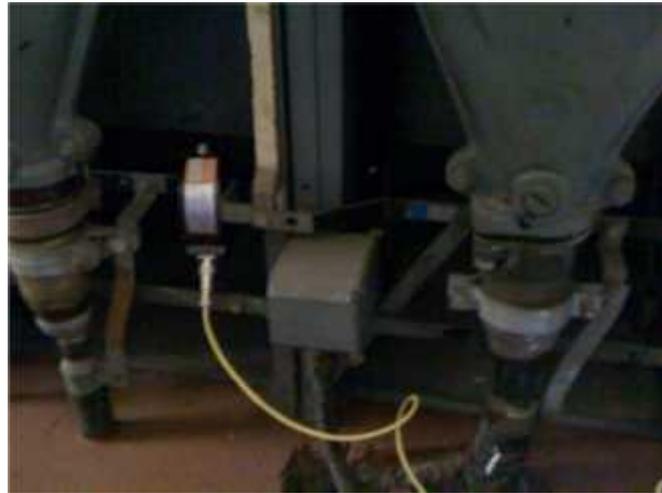
Placement of the HFCT
FIGURE 5

The HFCT uses inductive coupling to detect PD pulses flowing to earth. The HFCT is capable of picking up both local PD in the cable end box and also the lower frequency PD pulses coming from down the cable. FIGURE 5 illustrates the deployment of a 300MHz split-core HFCT placed around the cable earth strap. To be effective there should be insulation between the cable earth strap and the circuit breaker earth at the cable end box of the circuit breaker, i.e. maintaining zonal isolation.

(a) On the Cable Earth Strap

(b) Earth Strap of the Adjacent Circuit Breaker

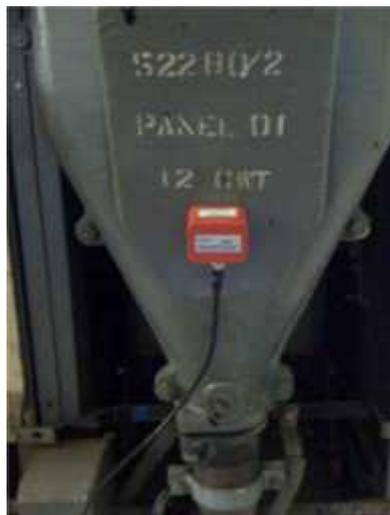
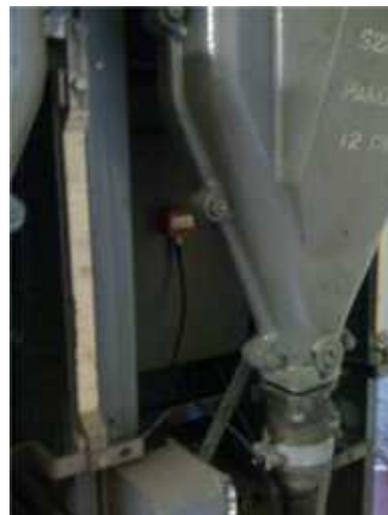
FIGURE 7

The most advantageous setup for metal-clad switchgear is to use an HFCT sensor in conjunction with a TEV sensor. Transient Earth Voltage (TEV) measurements work on the principle that if a PD occurs within metal clad switchgear, electromagnetic waves escape through openings in the metal casing. The electromagnetic wave propagates along the outside of the casing generating a transient earth voltage on the metal surface. TEV sensors are “capacitive couplers”, which when placed on the surface of metal cladding can detect TEV pulses as a result of PD internal to the switchgear. Bandwidths of $>100\text{MHz}$ are needed to capture pulse rise-times of the order of nanoseconds that are typical of such pulses [12].

(a) Cable End Box

(b) Main Circuit Breaker Tank

Placement of Transient Earth Voltage (TEV) couplers
